MLS[®] Laser Therapy: A Case Study

Tammie Hodge, DVM
River Mill Animal Hospital >>
Tampa, FL 33647

Treatment of Rattlesnake Bite Infected Wound

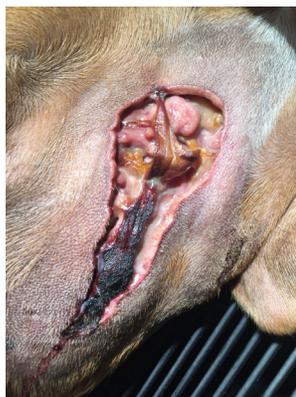
Marley initial exam 9/16/2016

Examination revealed a large open wound at the ventral cranial thorax with surrounding flat firm subcutaneous layer, discharge and strong odor. Also present: wound necrosis and skin sloughing at the original bite sites secondary to the venom.

Debrided the wound to remove black skin and yellow tissue. Diffused firm swelling under and including the tissue surrounding the wound. Betadine flush followed by laser therapy daily for 12 days to combat wound contamination and chronic inflammation. Bandage with silver sulfadine changed twice daily.

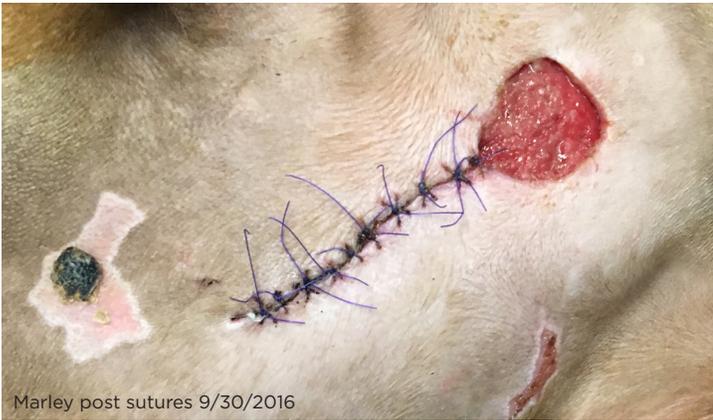
September 29: Marley presented for her 11th laser treatment. Her wound had shrunk in size and wound depth was less. Superficial skin exposing muscle layer was open and no further sloughing had occurred. Appeared ready to close the skin in some areas. Wound debridement with a #10 scalpel blade along the muscle and skin margins & able to close 3/4 of the wound. Skin layer 3-0 PDS cruciate mattress pattern. The proximal portion of the wound was too wide to close via sutures and was expected to shrink and heal with laser treatments and cleaning.

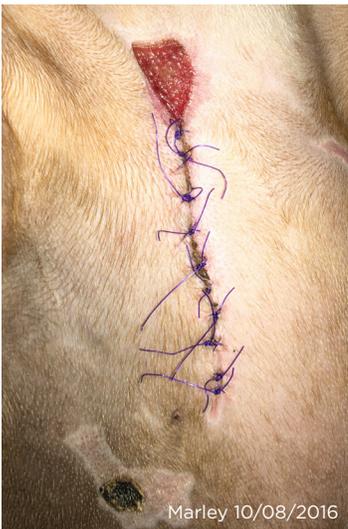
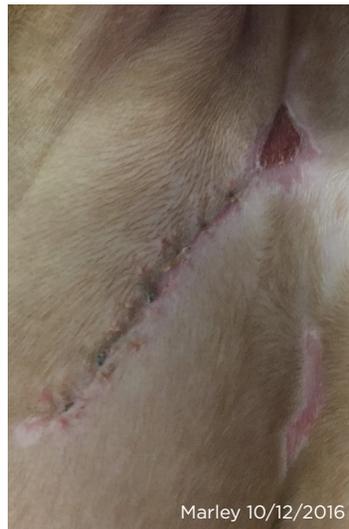
September 30 - October 8: Marley presented for her 12th through 15th laser treatments. Wound continued to heal very well through suture removal on October 12th.

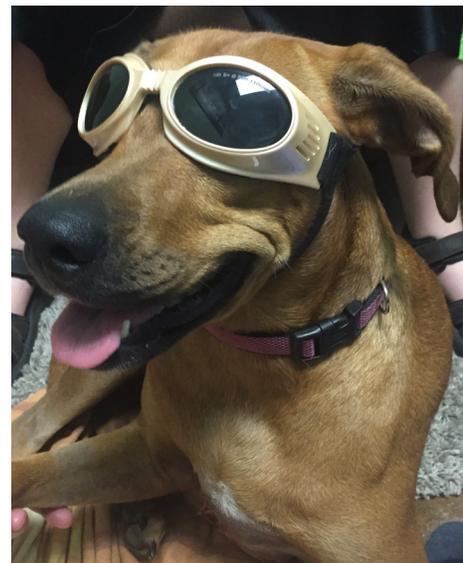
Marley saw improvement in her bite wound after just a few MLS Laser treatments. Tissue and skin continued to regenerate and heal as treatment progressed and improved vastly after closing via sutures.
