# MLS® Laser Therapy for the management of a non-healing venous leg ulcer: A Case Report.

Jill Pellizzon<sup>1</sup>

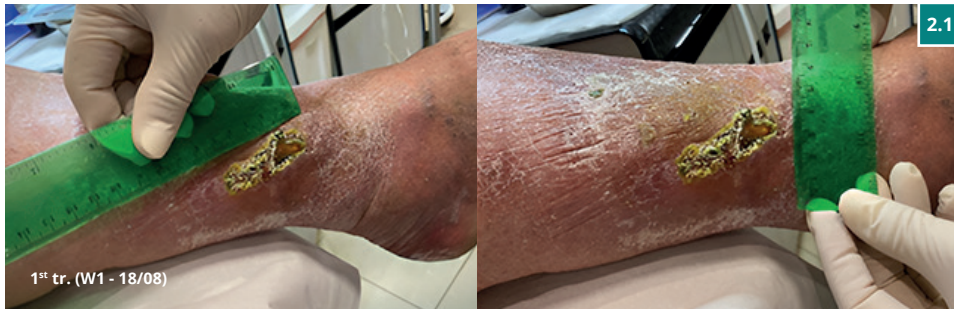
**Figures 2.1**  
Baseline visit, ulcer condition before debridement and first laser treatment.

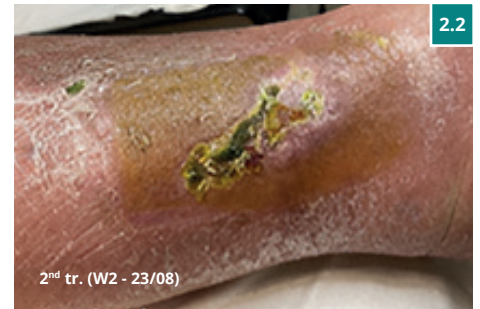
**Figures 2.2**  
Ulcer condition before removing necrotic tissue.

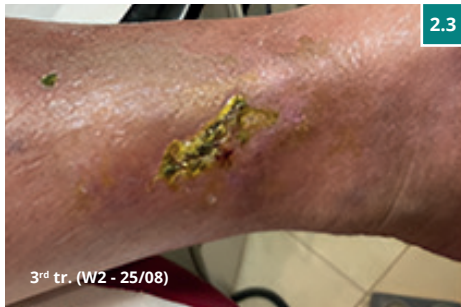
**Figures 2.3**  
Ulcer condition after debridement and 3<sup>rd</sup> MLS® laser treatment.

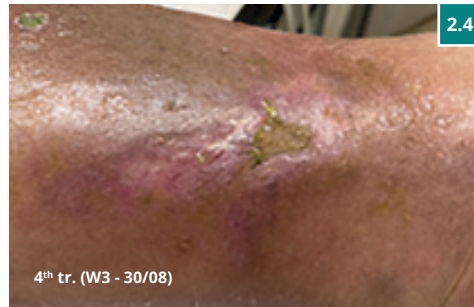
**Figures 2.4**  
The ulcer present depth reduced and eschar lifting with minimal scarring and surrounding skin much improved with significant reduction in leg's oedema.

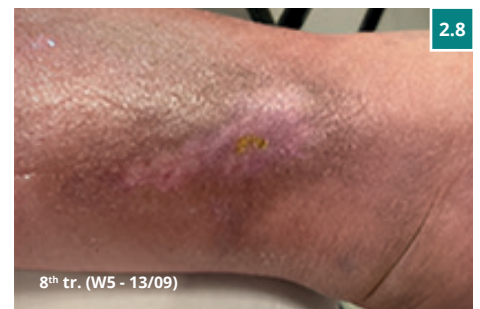
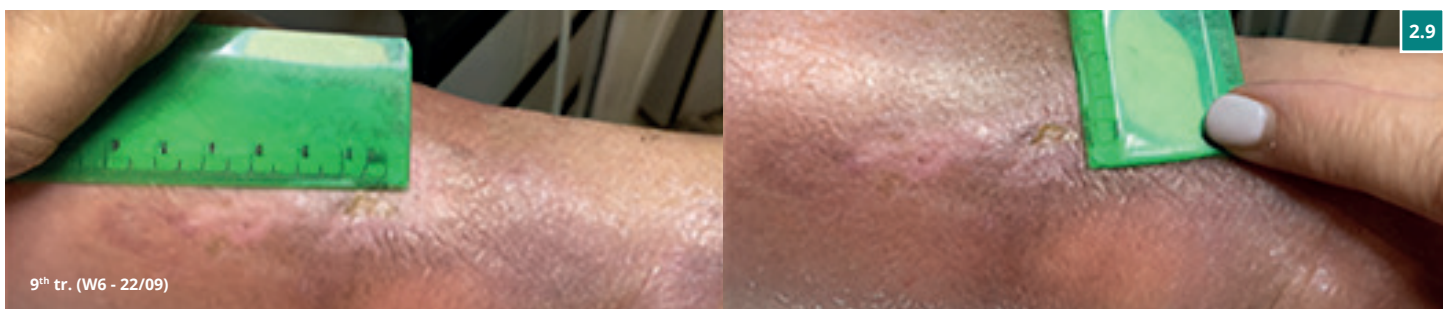
**Figures 2.9**  
Ulcer condition after 5 weeks since the first treatment, superficial ulcer's area of 0.45cm<sup>2</sup>.
